Gold Coin Electrode Holder

Beryllium Copper Nipple Electron Beam Welded to Chromium Zirconium Copper Holder Body

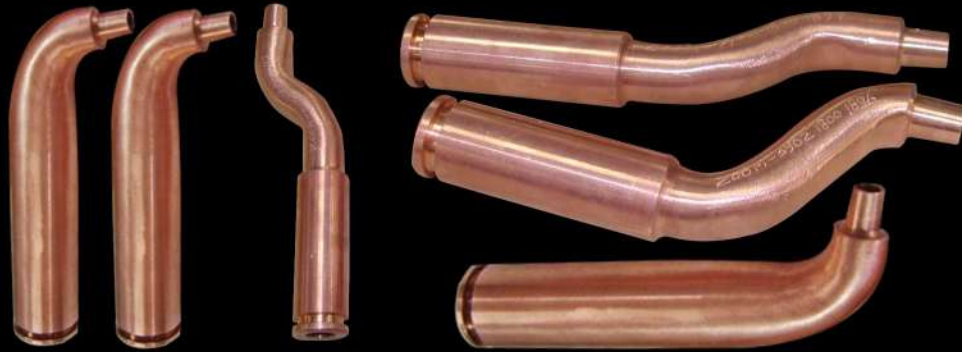
Existing Holder

Full Electrode Holder Constructed in Chromium Zirconium Copper

Problems associated with Electrode Holders made up of Chromium Zirconium Copper:

- Lower hardness in nipple area.
- Tip wear out issue is high.
- Life of Holder is less.

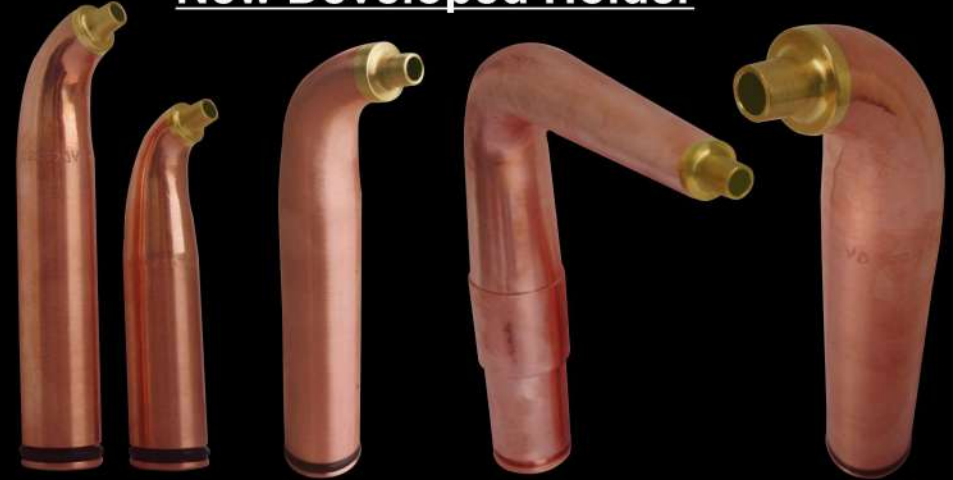
New Developed Holder

Beryllium Copper Nipple Electron Beam Welded to Chromium Zirconium Copper Holder Body

- Beryllium Copper (36C to 44C) has more hardness compared to Chromium Zirconium Copper (70B to 83B).
- Beryllium Copper material Electron Beam Welded onto Chromium Zirconium Copper at nipple area.
- Due to high hardness tip wear out issue is less.
- Life of holder is more.

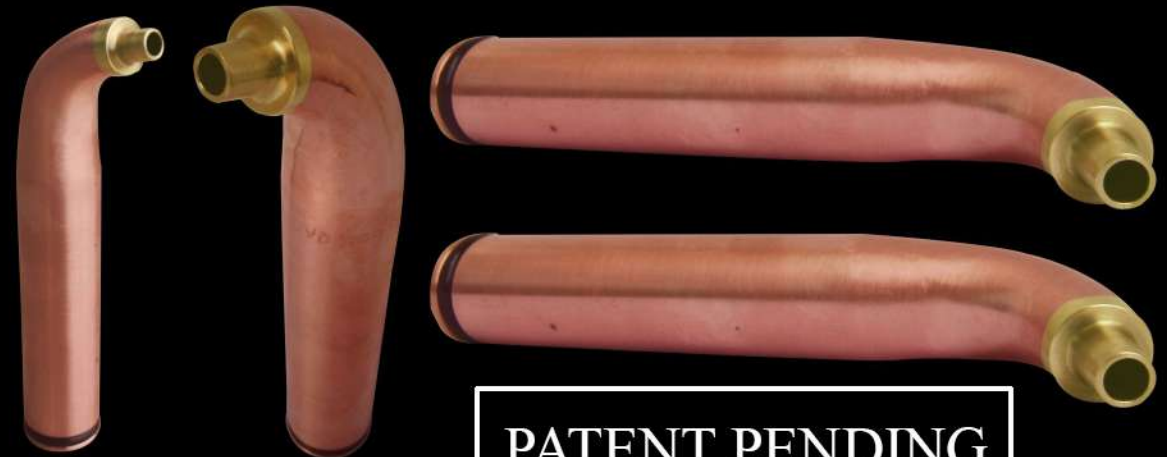
**2% Beryllium Copper + Chromium Zirconium Copper
(Gold Coin Electrode Holder)**

Alloy	UNS No	Typical Composition	Hardness
Mipalloy3ZR (Cr Zr Cu)	C18150	Cr: 0.5-1.5% Zr: 0.05 - 0.25% Rest: Cu	70 - 83 HRB
Mipalloy 4 (2% Be Cu)	C17200	Be: 1.8-2.0%, Co: 0.2% Si: 0.2%, Al: 0.2% Rest: Cu	36 - 44 HRC
